Debris/Ice/TPS Assessment and Integrated Photographic Analysis of Shuttle mission STS-105

**DEBRIS/ICE/TPS ASSESSMENT and
INTEGRATED PHOTOGRAPHIC ANALYSIS
OF SHUTTLE MISSION STS-105**

Armando Oliu
Process Engineering/Mechanical System Division/ET-SRB Branch,
Kennedy Space Center, Florida

August 10, 2001

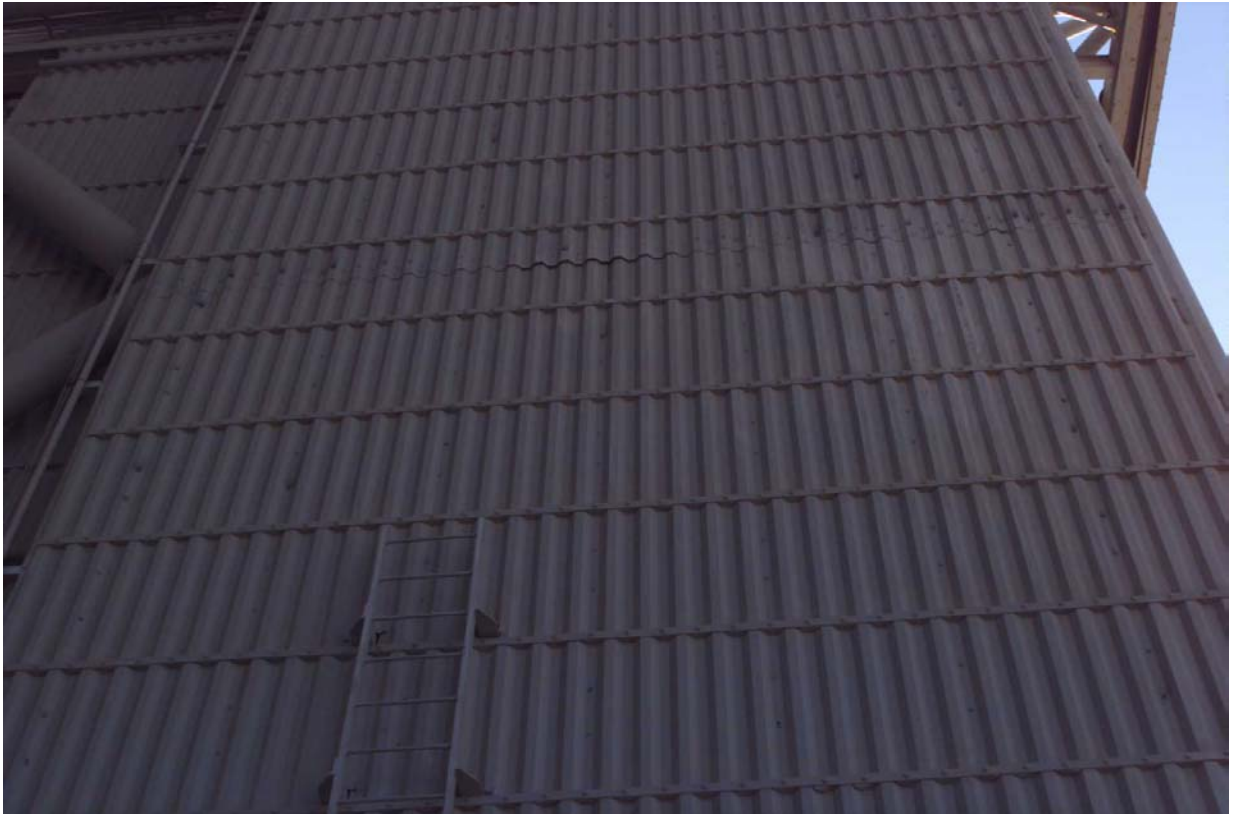
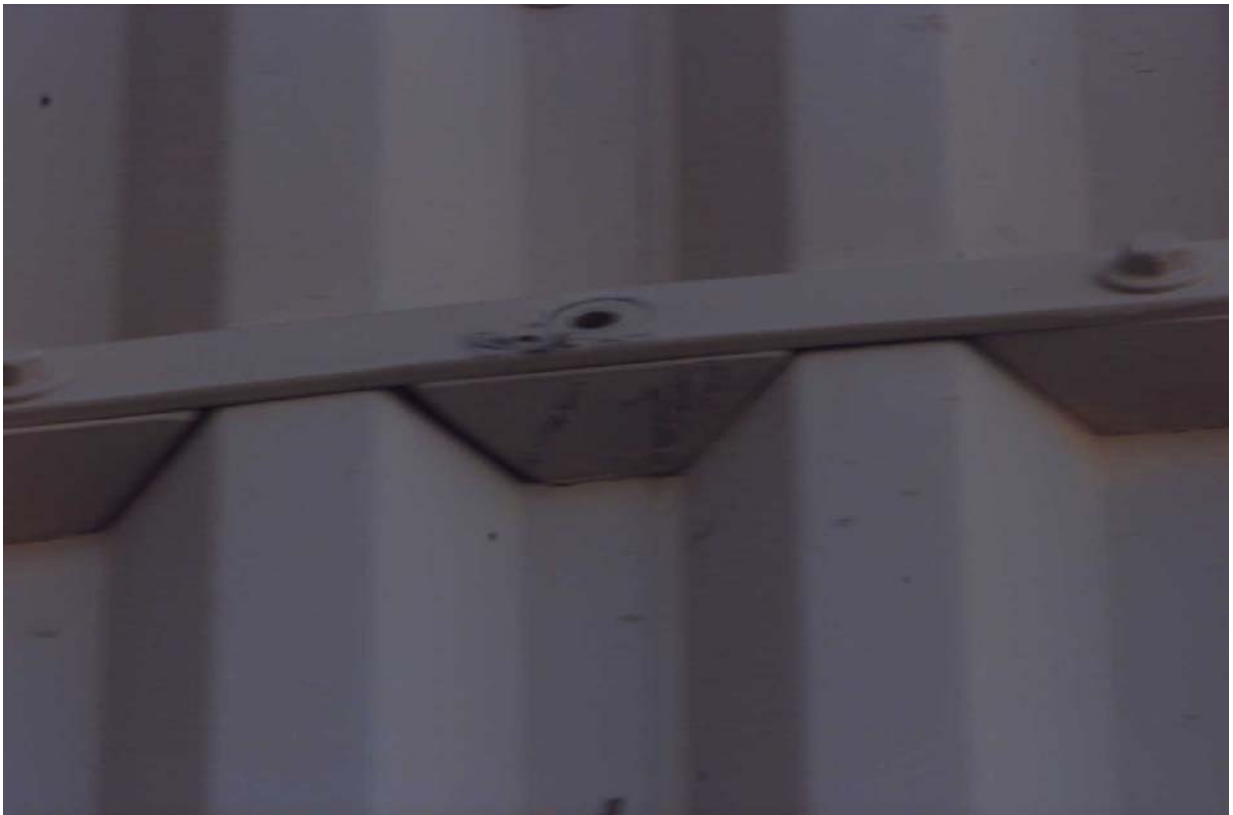
Photo 2: Missing fastener on OWP

The west OWP corrugated sheeting was missing a fastener head on the groove wedge. This was documented on a facility PR (PV-6-377725). However, Debris Team expressed concern that wedge may not be held in place by remaining fastener portion. The decision was made to secure wedge with another fastener. This item was in-work at the conclusion of the Debris Inspection.

Facility PR (PV-6-377725) was picked up to document the missing a fastener head on the groove wedge.

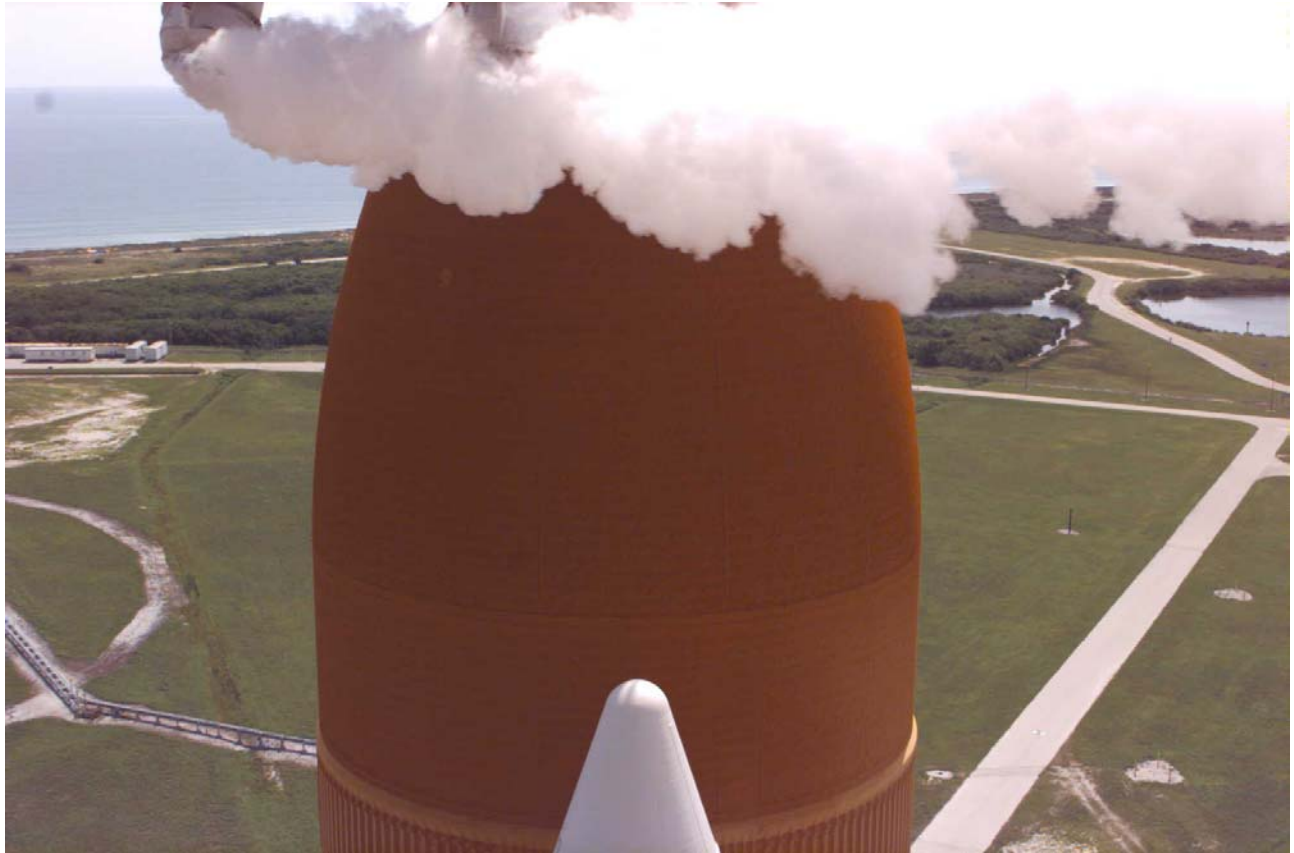
Photo 3: LO2 tank acreage.

Very little condensate was present on the LO2 tank acreage. Surface temperature ranged from 72 to 90 degrees Fahrenheit. There were no acreage TPS anomalies.

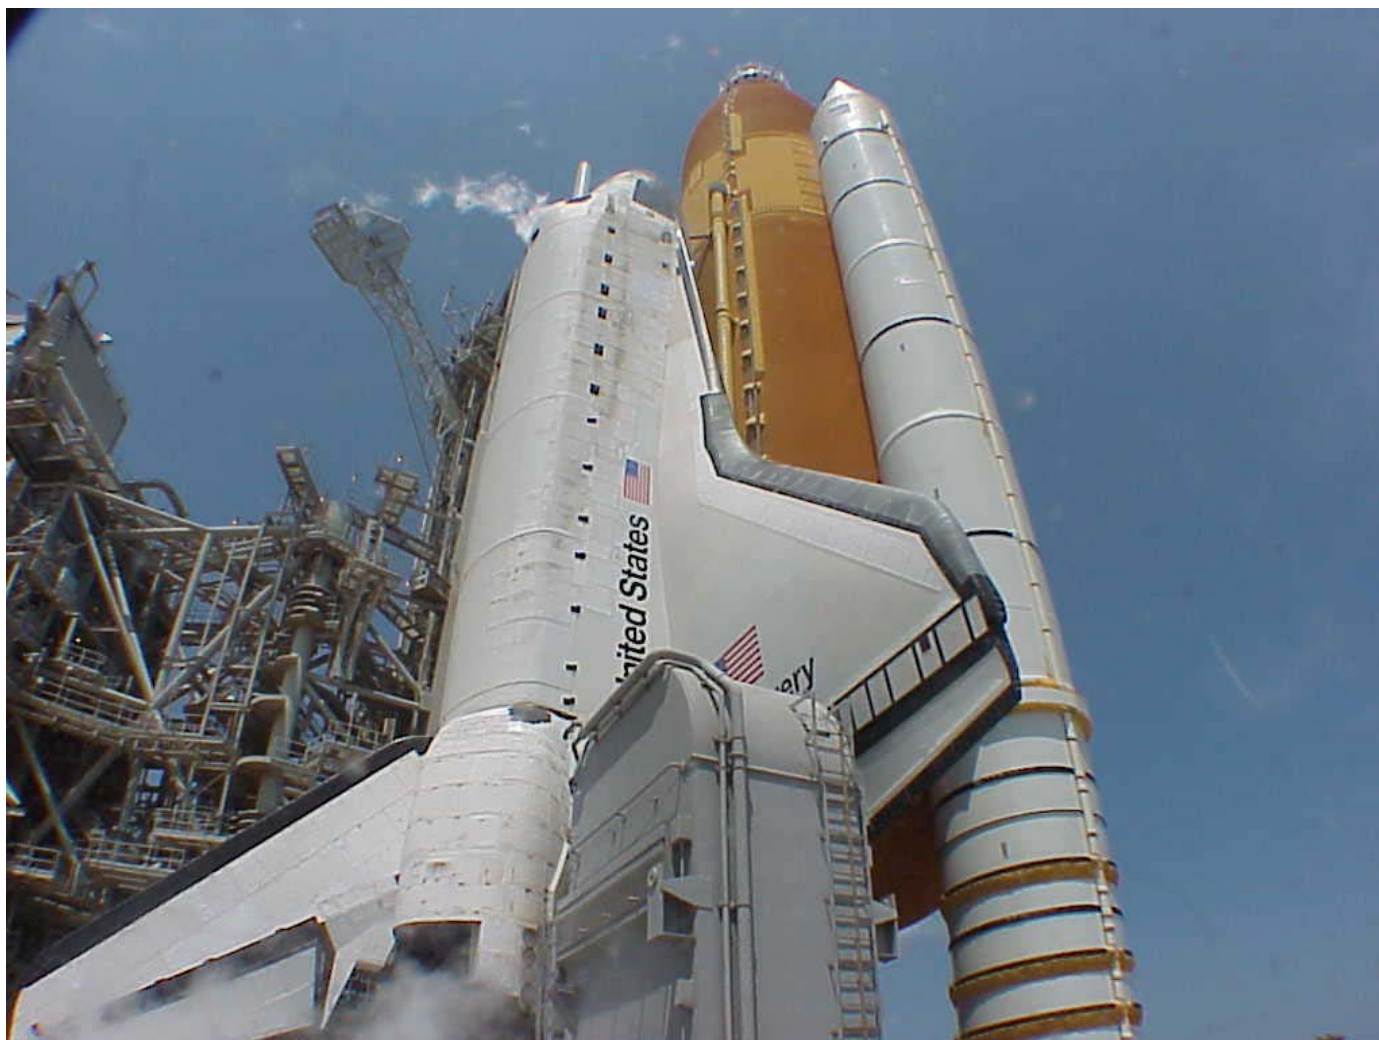
Photo 4: Overall view of Launch Vehicle and view of LH2 tank.

The LH2 tank was wet with moderate condensate on the upper portion and significantly more condensation at the aft end. Surface temperature ranged 76 to 92 degrees Fahrenheit. There were no acreage TPS anomalies.

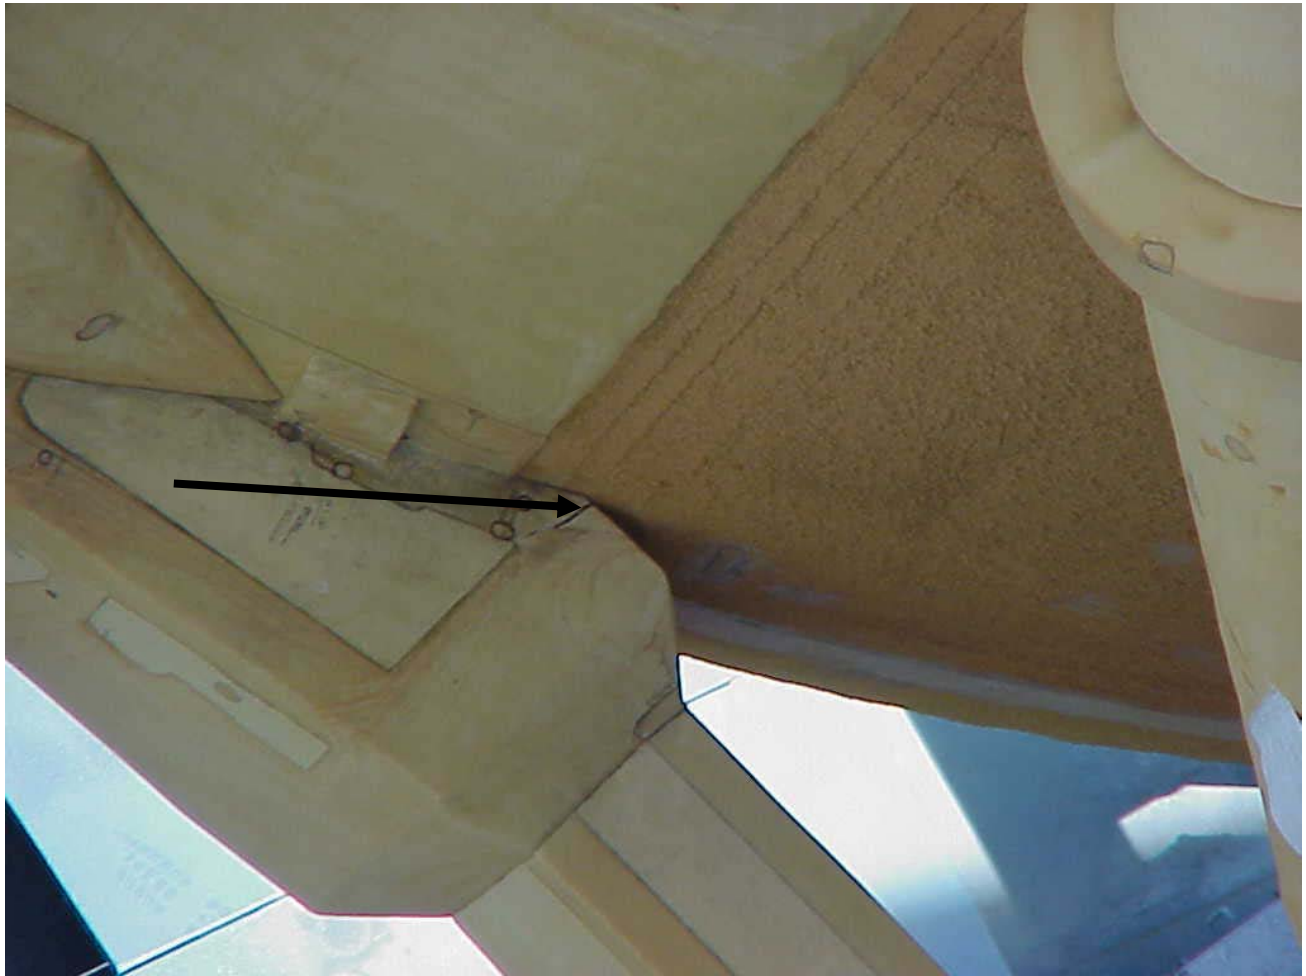
Photo 5: Crack in -Y Vertical Strut TPS

A 4 inch long and 3/8 inch wide stress relief crack was observed in the -Y vertical strut TPS with no offset. This condition has been observed on previous vehicles and found acceptable for flight per the NSTS-08303 criteria.

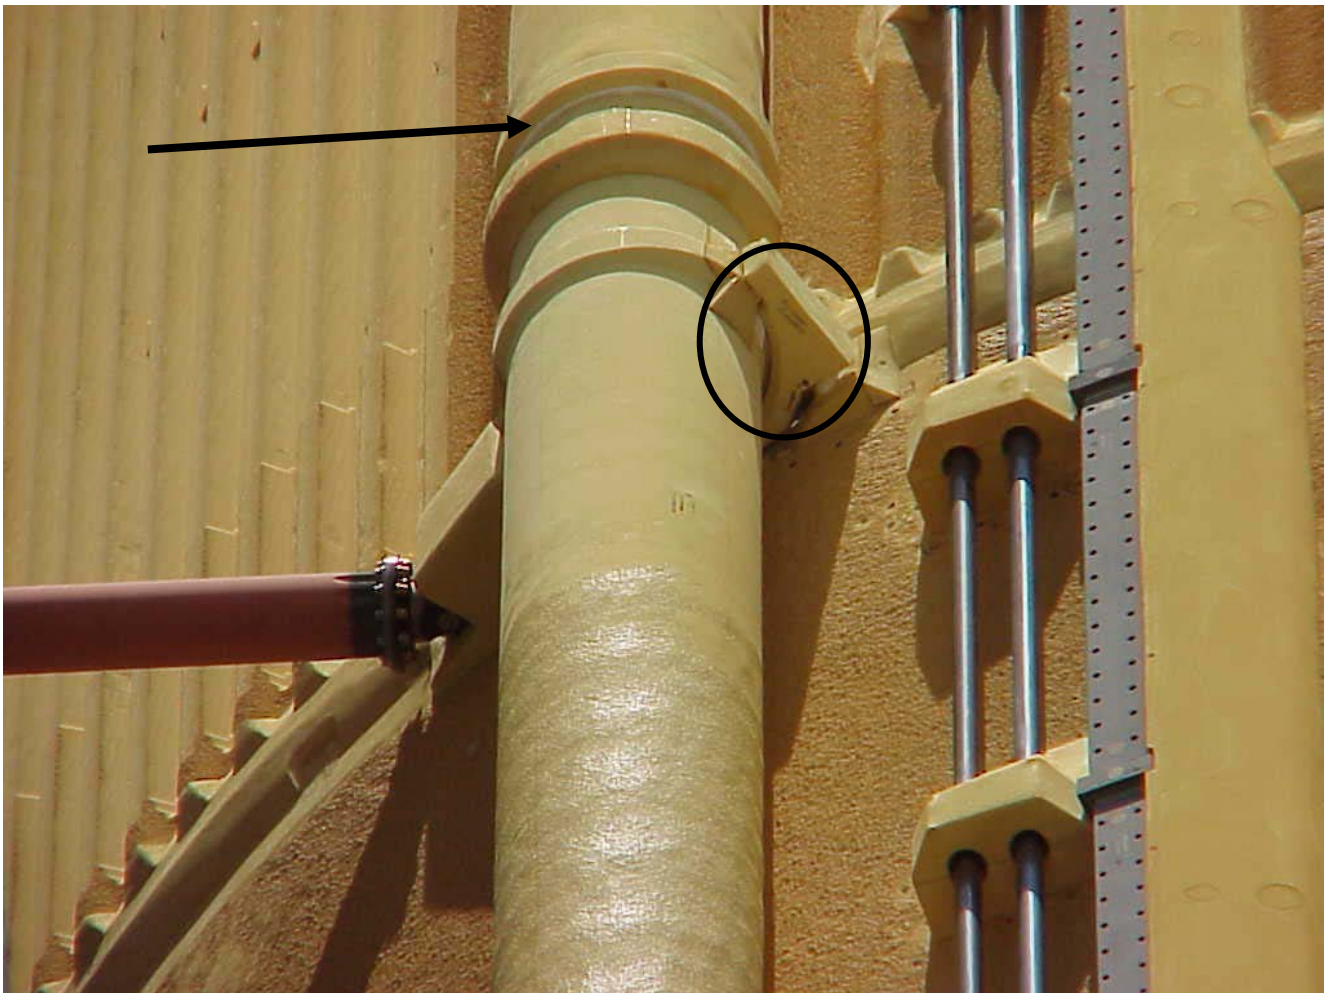
Photo 6: Ice/Frost on LO2 F/L

Typical ice/frost on the LO2 feedline support bracket attachments and in forward bellows.

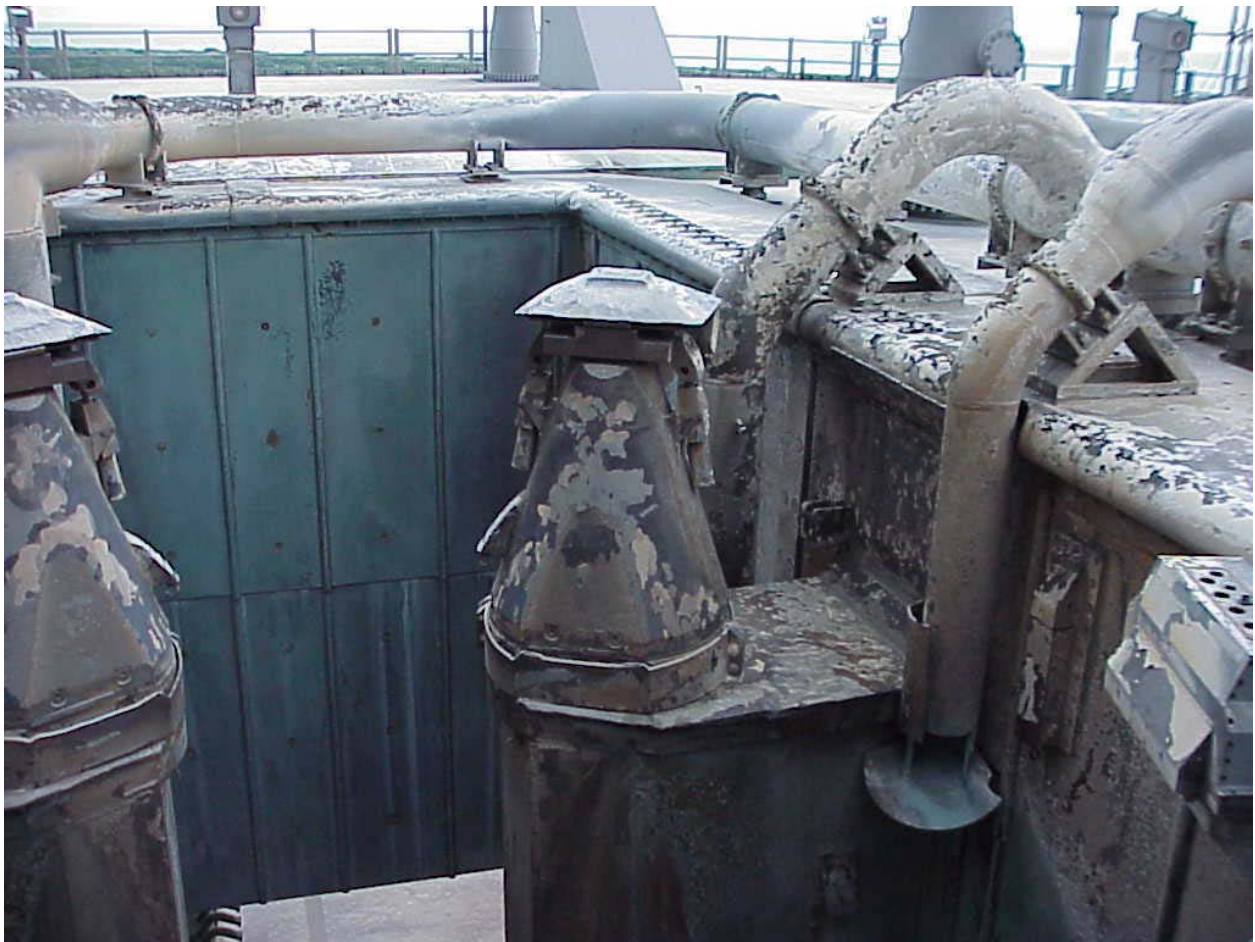
Photo 7: General view of MLP post launch.

Typical erosion on North holddown posts and blast shields.

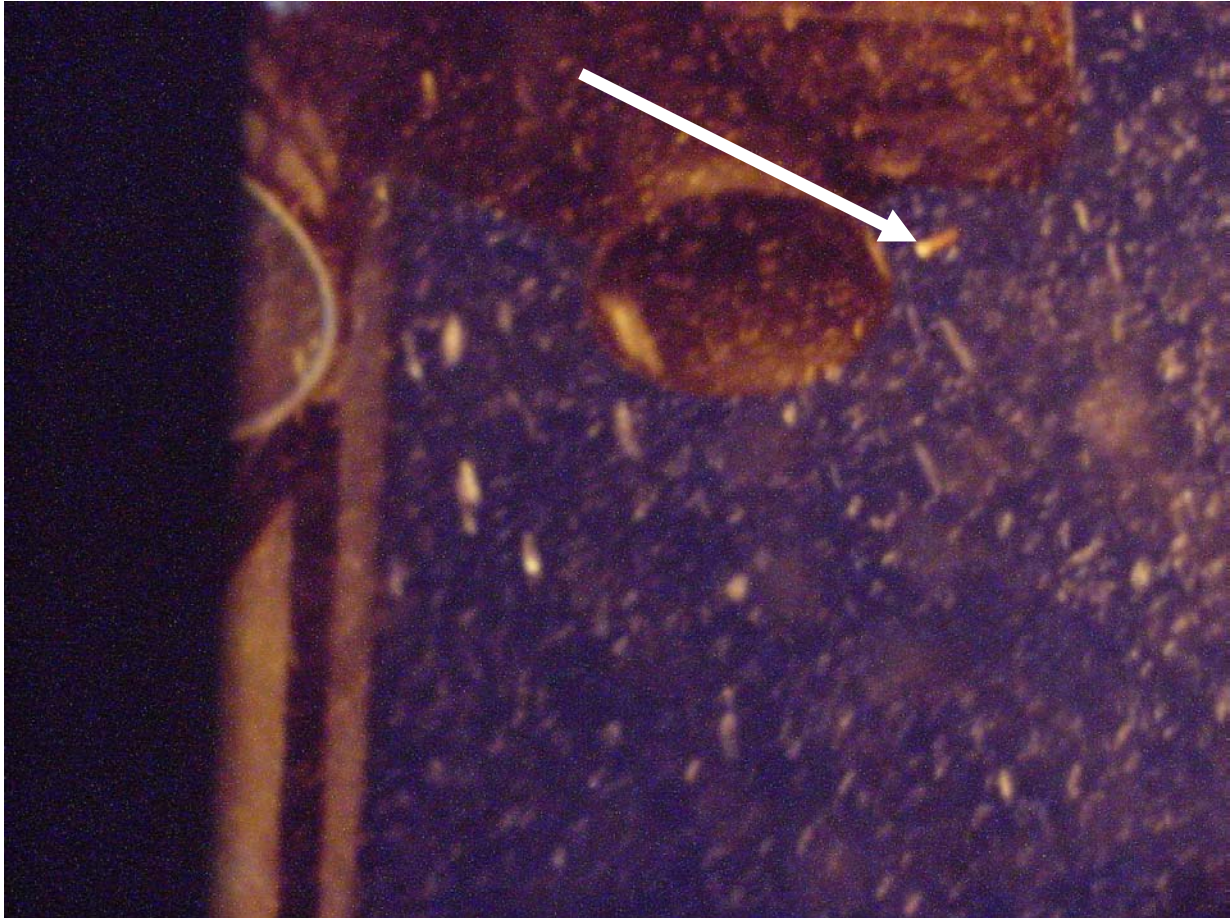
Photo 8: Cylindrical debris seen on E-18

Probably 2 ½ to 3 inch long by 0.75-inch diameter facility bolt from HDP #5 haunch.

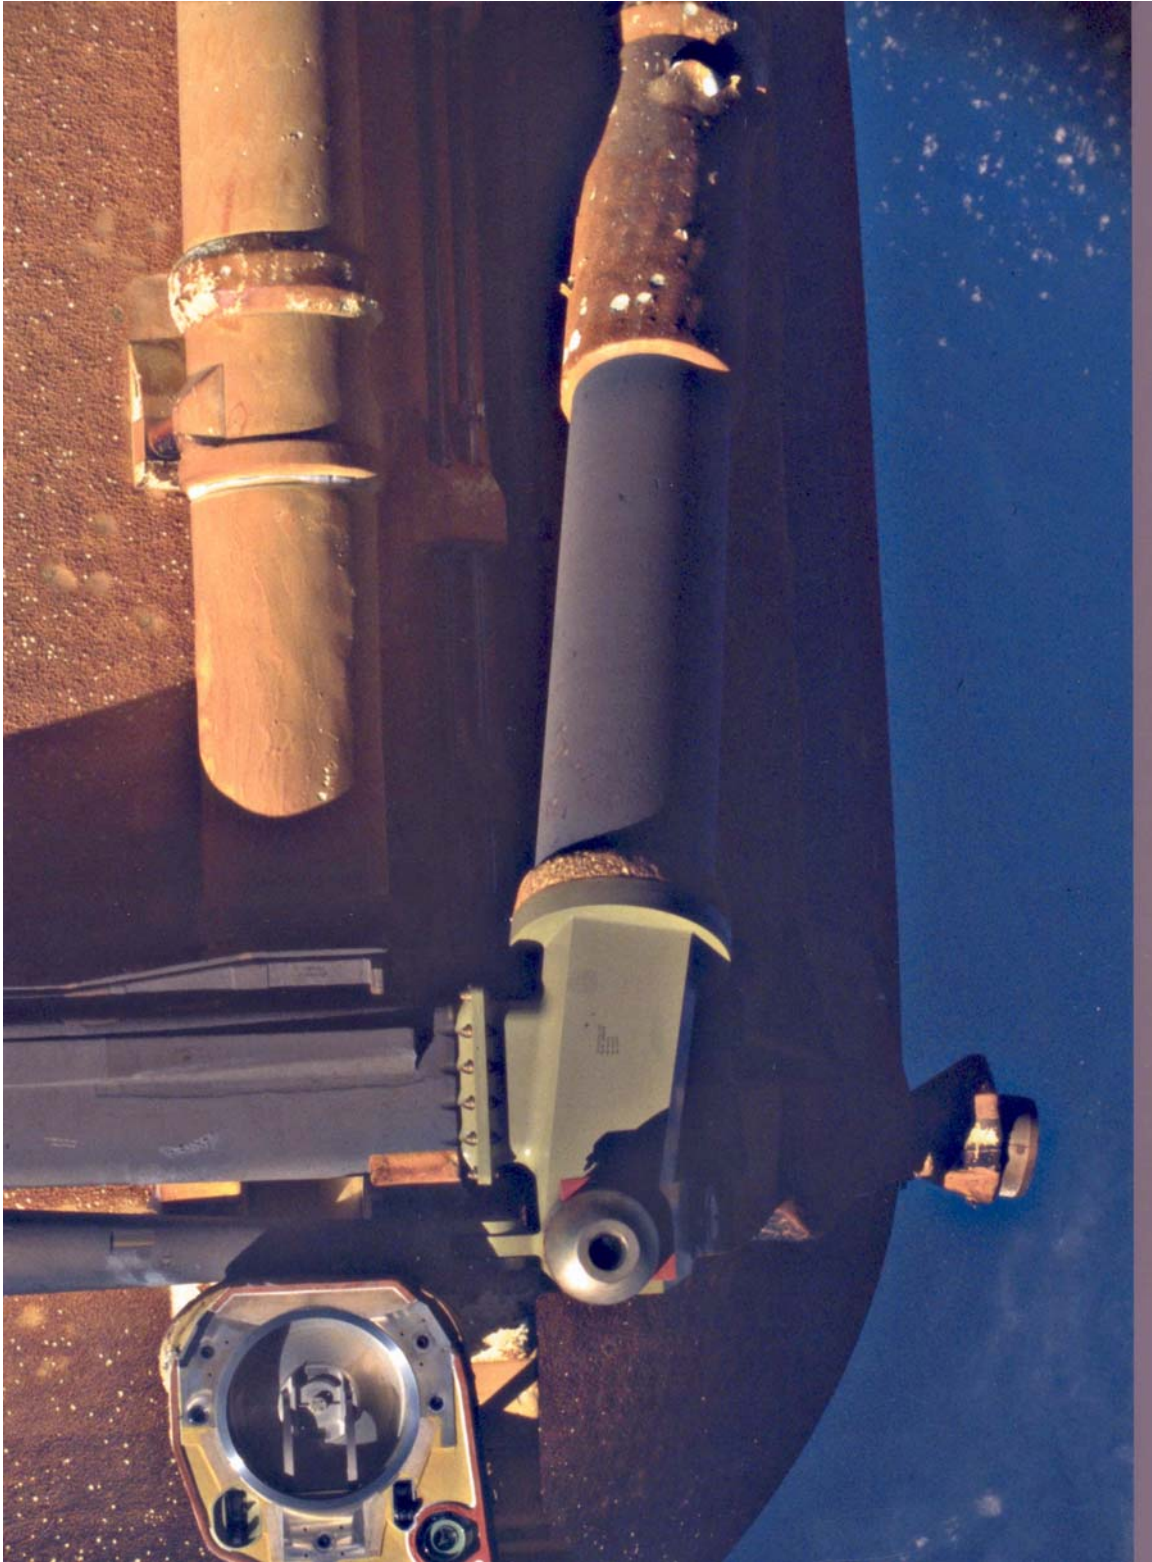
Photo 9: ET LO2 ET/ORB Umbilical

An 8-inch diameter divot, with foam still partially attached, was located on the +Y thrust strut near the forward flange. Several smaller divots (less than 2 inch dia.) on +Y thrust strut. Erosion of the LO2 feedline flange closeouts appeared typical.

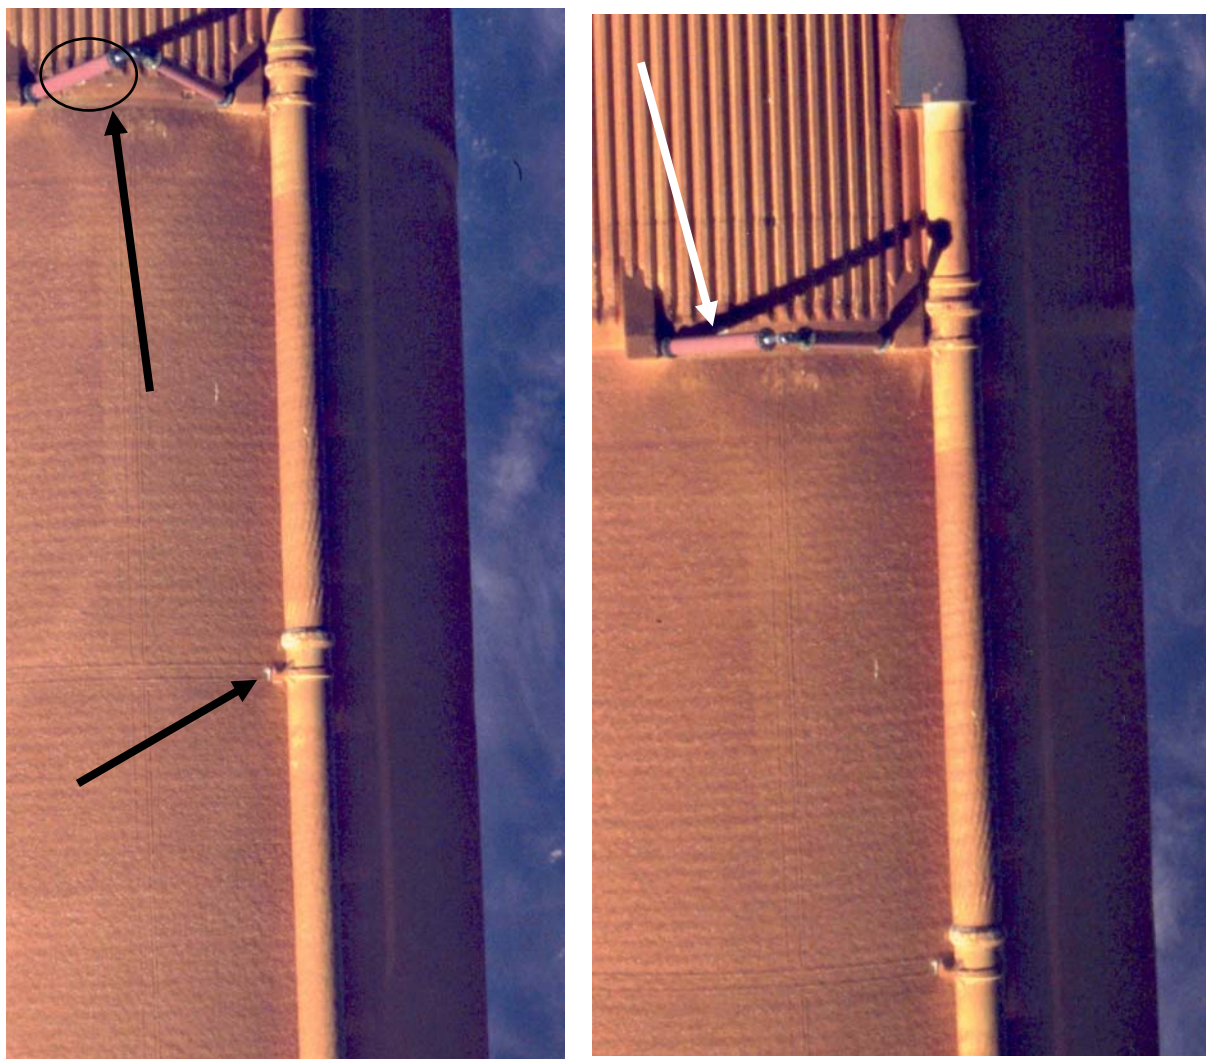
Photo 10: Divots in LH2 Tank Flange Closeout and in LH2 Tank Acreage

Small divots observed on the intertank-to-LH2 tank flange between the bipods. Divot observed on the LH2 tank near the base of the LO2 feedline support bracket closeout at station Xt-1377.

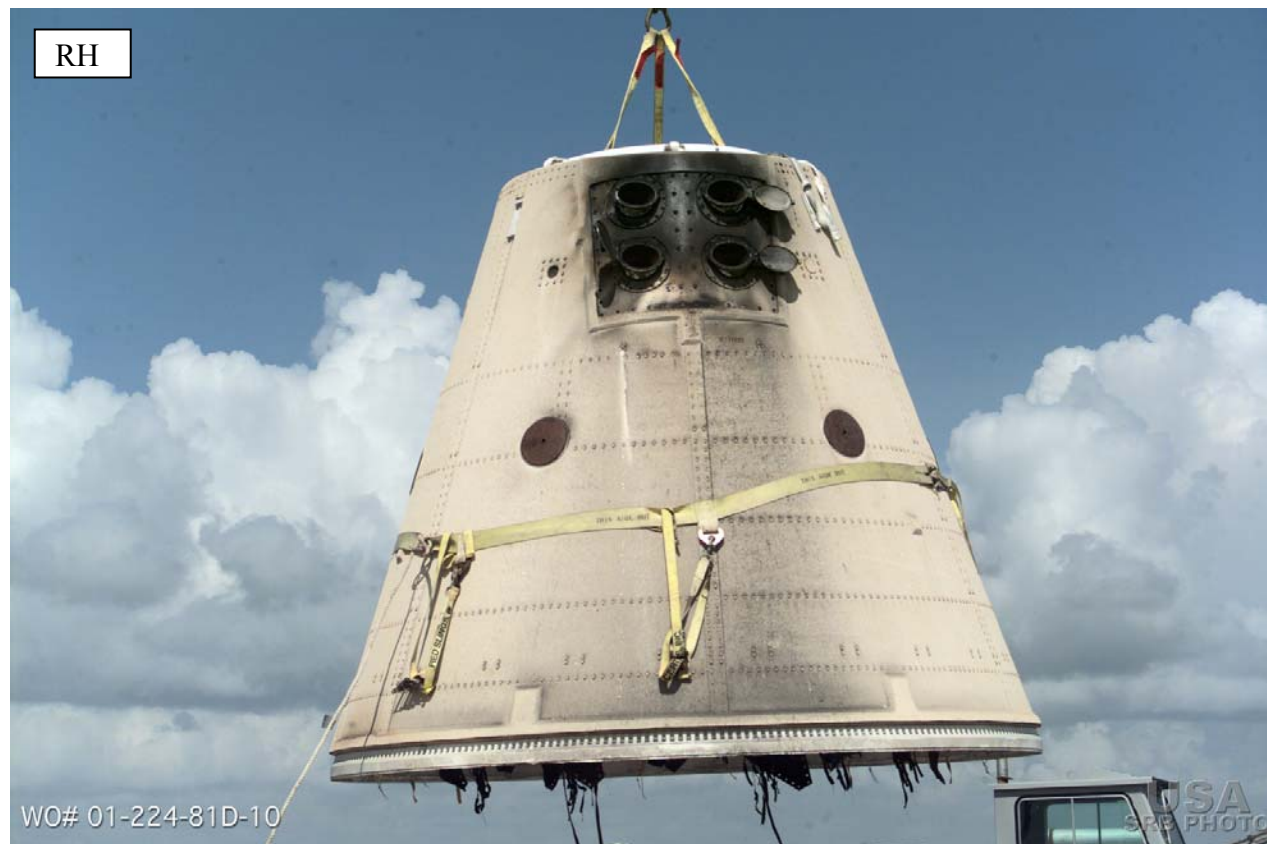
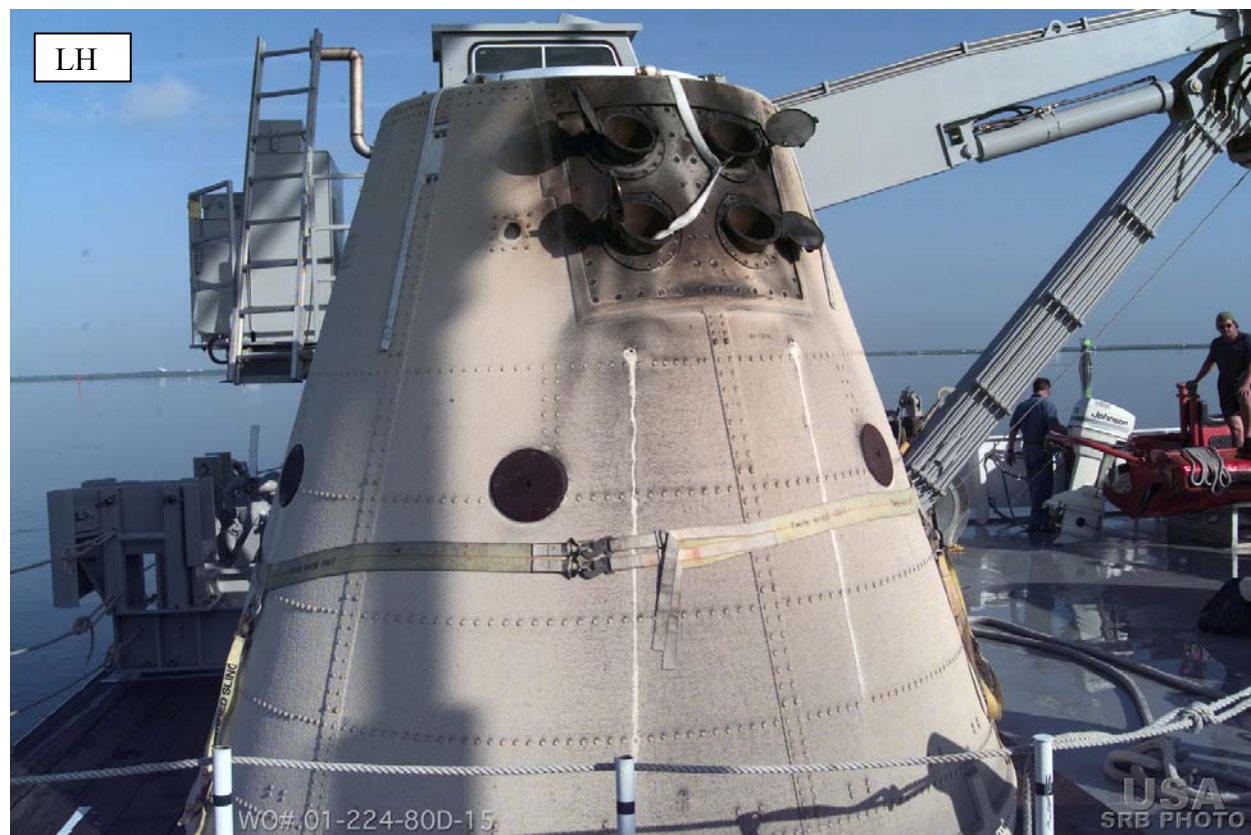
Photo 11: Frustum Post Flight Condition

The frustums exhibited no debonds/unbonds or missing TPS. Seven of eight BSM aero heat shield covers had locked in the typical opened position. One cover from RH frustum was missing.

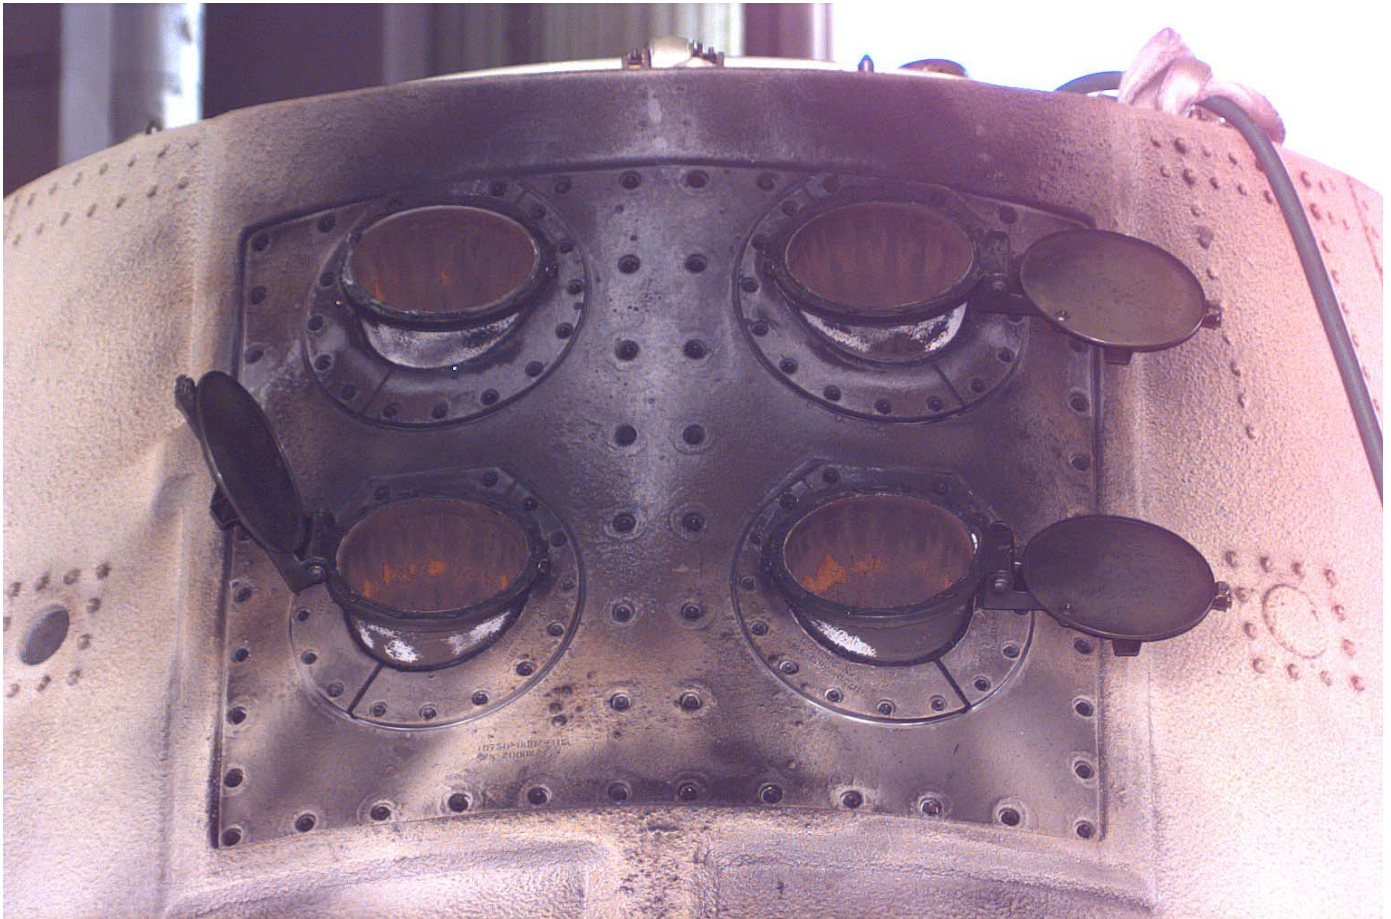
Photo 12: RH Frustum Post Flight Condition

The RH SRB top/left position forward BSM cover was missing. Fracture plane revealed no sooting effects, this is indicative of water impact damage.

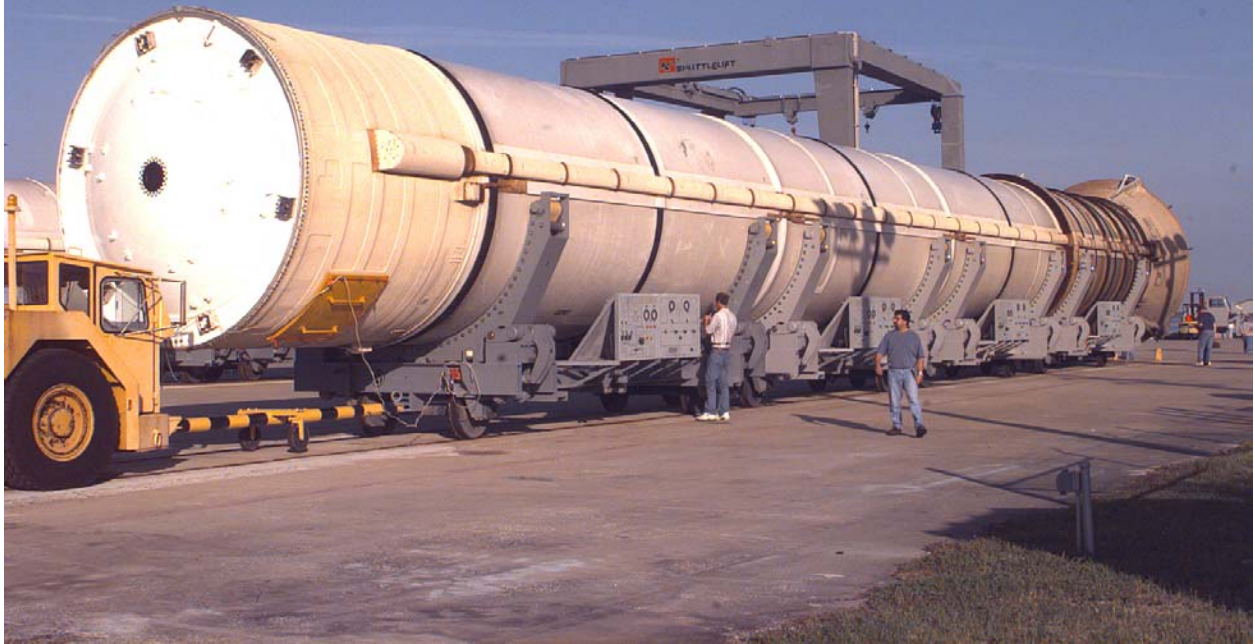
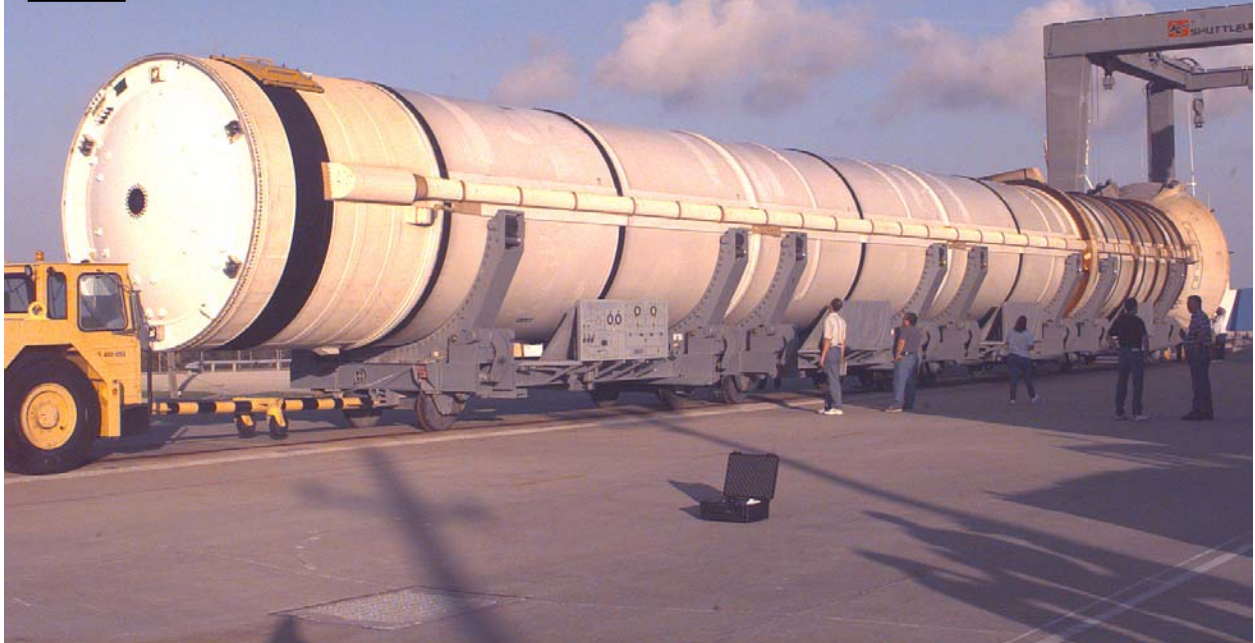
Photo 13: SRB Post Flight Condition

Both SRB's were found in good condition regarding debris assessment

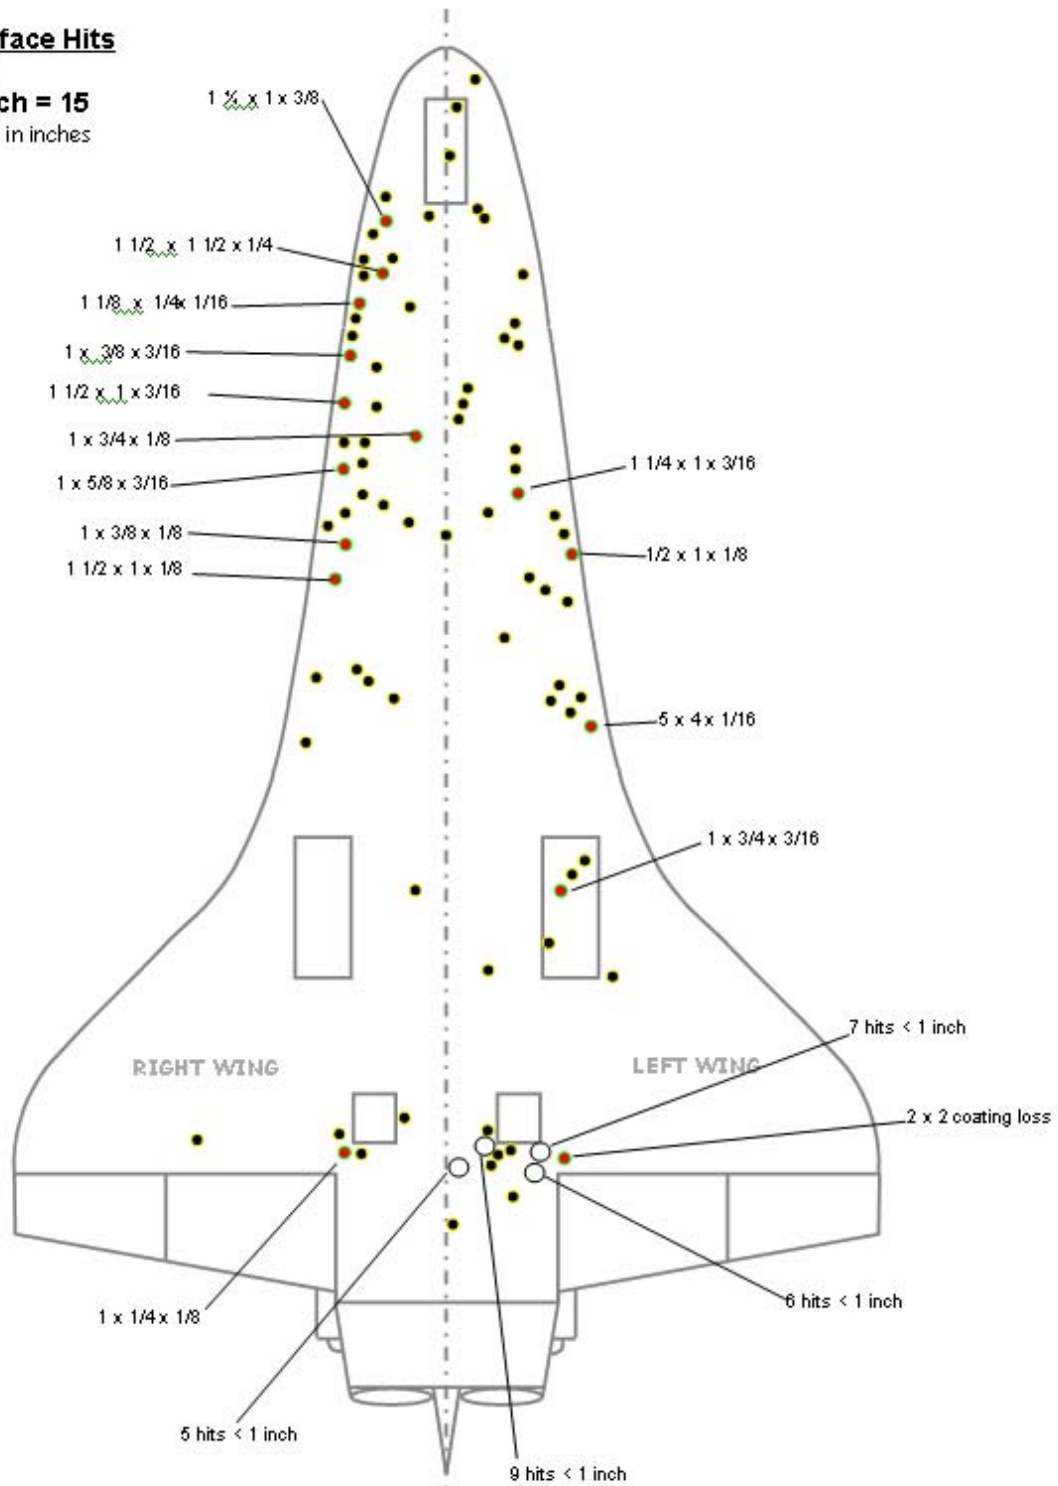
Figure 1: Orbiter Lower Surface Debris Damage Map

Post landing inspection of Orbiter tiles showed a total of 144 hits, of which 25 had a major dimension of 1-inch or larger. The Orbiter lower surface sustained 108 total hits, of which 15 had a major dimension of 1-inch or larger, both numbers are within family. The majority of the hits (57 total with 11 greater than 1-inch) were located in the area from the nose landing gear to the main landing gear wheel wells on both left and right chines. The pattern and size ratio of these hits is indicative of damage from ET foam loss. This is the highest number of hits in this area since the implementation of ET intertank foam venting.

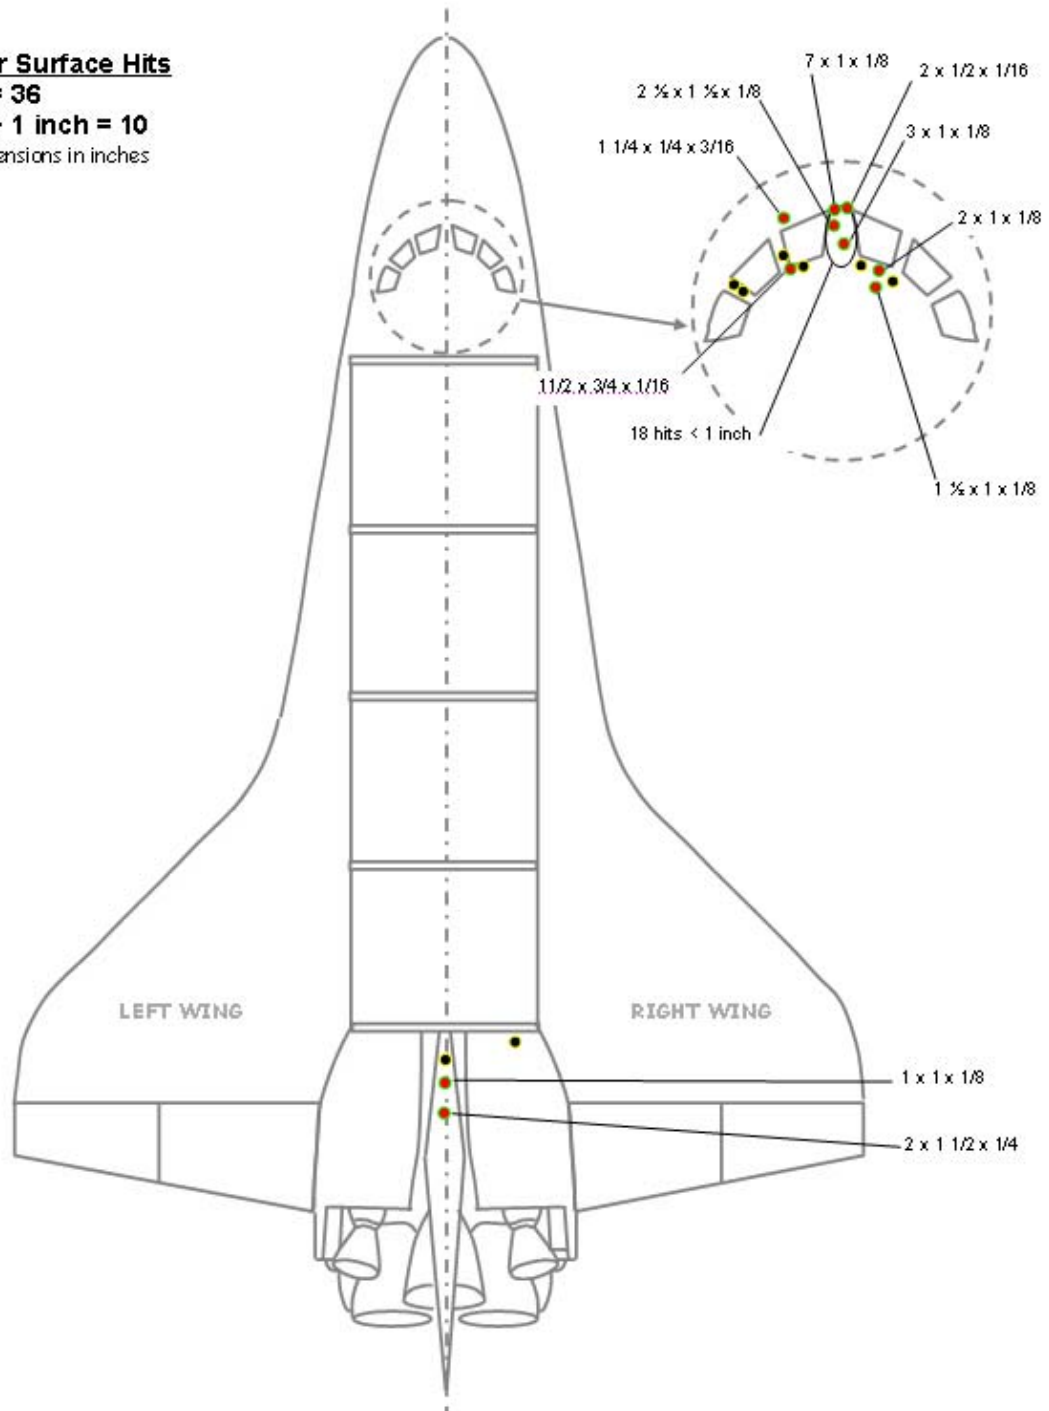
Figure 2: Orbiter Upper Surface Debris Damage Map

Upper Surface Hits
Hits = 36
Hits > 1 inch = 10
 All dimensions in inches
